## Systems of information, information nets, and information black holes

## An Information Black Hole

## Twin Towers investigations as a symbol of science in the 21<sup>st</sup> century

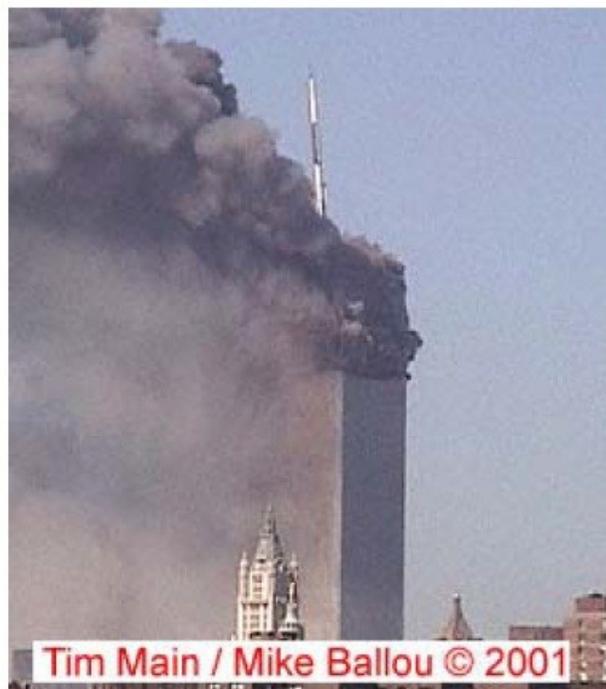
Figure 5–8. Collapse initiation and tilting of WTC 1 (view from the northeast).

"The section of the building above the impact zone tilted to the south (observed at about 8 degrees) as column instability progressed rapidly from the south wall along the adjacent east and west walls (see figure E-11), resulting in increased gravity load on the core columns."- page liv

" The section of the building above the impact zone began tilting to the south (observed at 8 degrees, table 5-2) as column instability progressed rapidly from the south wall along the adjacent east and west walls (see fig 5-8) resulting in increased gravity load on the core columns. The change in potential energy due to downward movement of building mass above the buckled columns exceeded the strain energy that could have been absorbed by the structure. Global collapse ensued." - p 314

(fig E-11 is the same as fig 5-8 shown below)

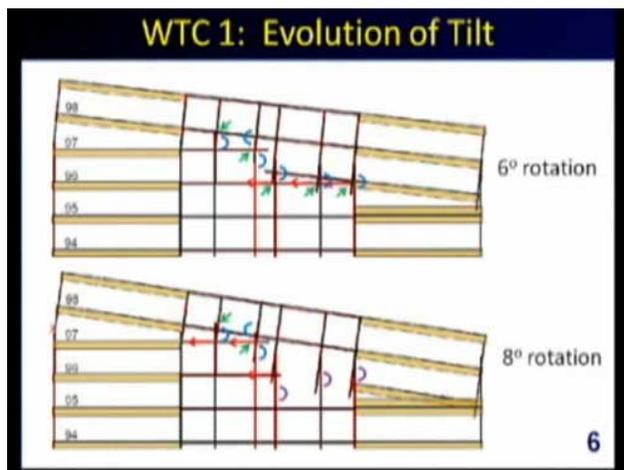
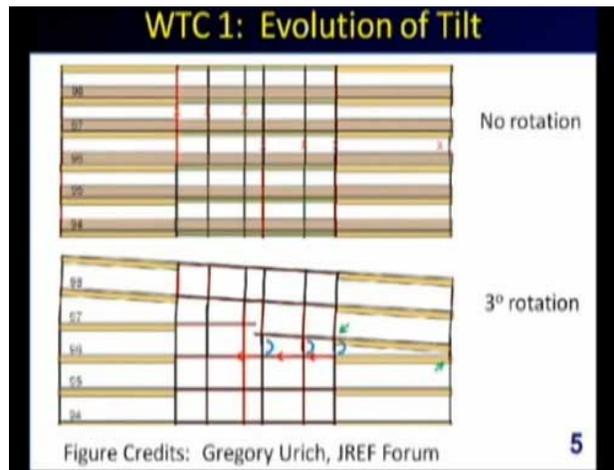
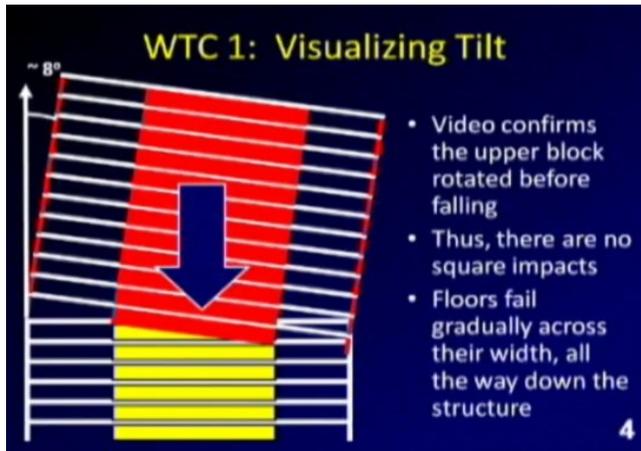
Two professional engineers drew the diagrams below to describe the collapse initiation movement for the North Tower during internet forum discussions:

It is obvious that they simply read the NIST quotes on the North Tower and drew what the NIST wrote. Their drawings match the NIST descriptions of the same movement. There is at least 8 degrees of tilt in both illustrations and both 'blocks' are tilting 'rigidly'. This was their understanding of what the NIST wrote in their final reports.

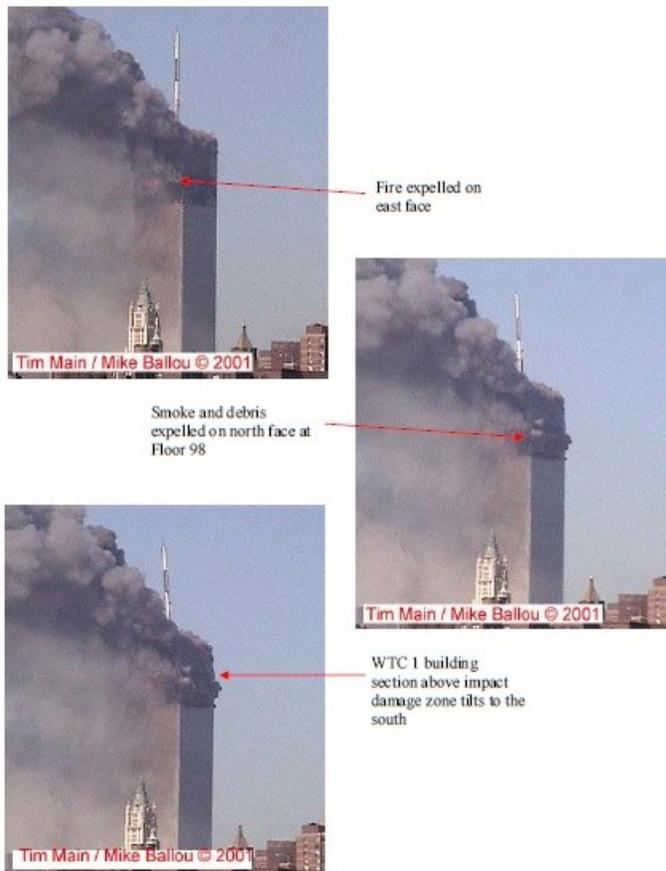
Figure 6-7. Expulsion of smoke and debris at WTC 1 Floor 98 on the east, north, and west faces.

In the following sequence all columns had failed before the second and third photographs were taken even though the NIST misrepresents the failures as occurring during the sequence shown:

Figure 6-7 shows how the NIST misrepresents the movement of the building as the columns originally failed. The earliest visible ejections actually emerge from the 95 floor along the west face. The northwest corner, the last group of columns to fail, had already failed by the time the second and third images were taken.

In this series of images and in each series to follow the NIST exaggerates the North Tower tilt angle by basically smearing out the column failure sequence far, far longer than is justified by any evidence. It is not clear that the NIST is using any systematic method at all to determine at which moment the last surviving columns on the northwest corner fail. The mappings and reconstructions linked earlier give a few precise techniques to determine the moment of failure of the northwest corner. Synchronized video then allows anyone to see the actual tilt motion during the column failure sequence. The NIST was incorrect by more than 800%.

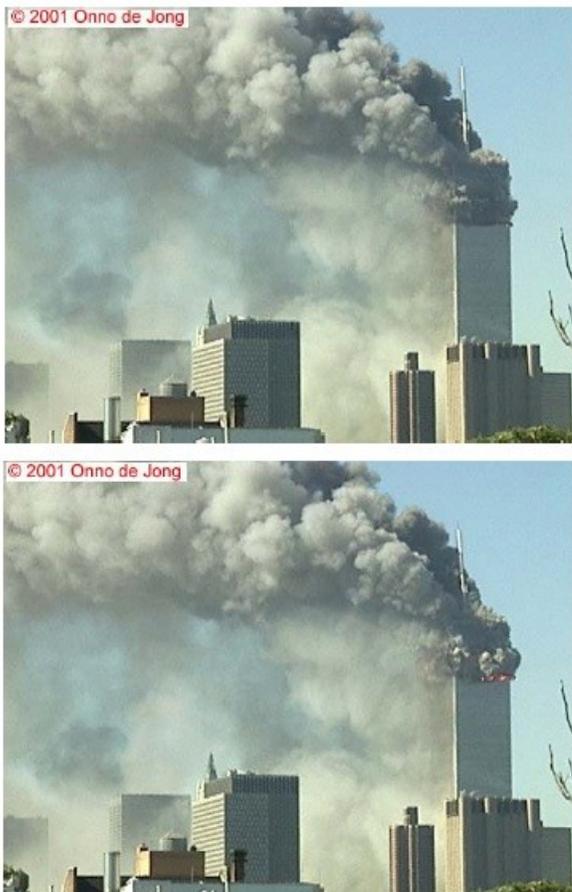
Figure 6-9. Smoke expulsion at Floor 98 from north and east faces at collapse initiation.

Likewise, all columns had failed by the time the 2 photos below were taken:

Figure 6-9 which shows how the NIST misrepresents the movement of the building as the columns originally failed. The northwest corner, the last group of columns to fail, had clearly failed by the time both of these images were taken.

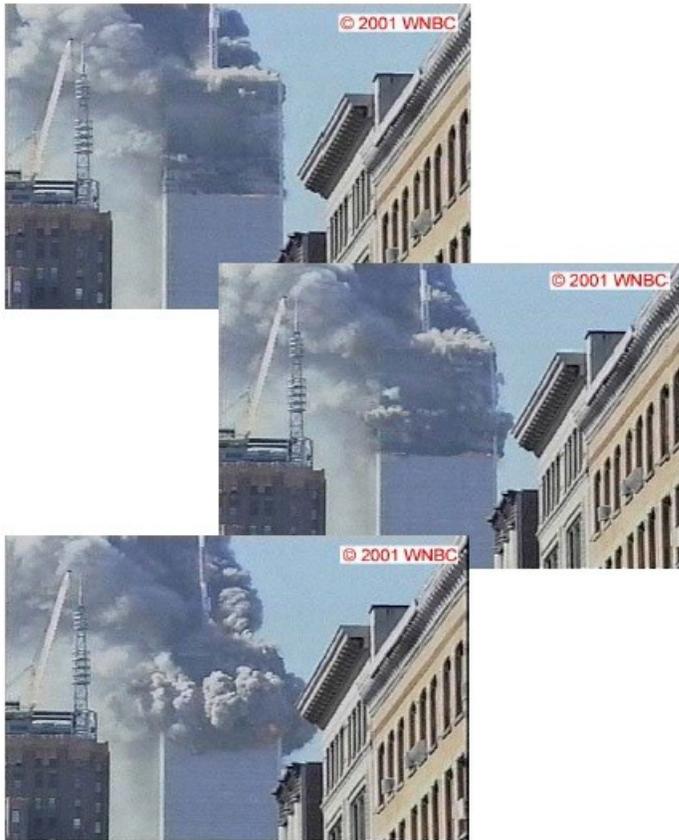
Figure 6-10. Rotation of WTC 1 building section above the aircraft impact zone toward the south as viewed from due north. Note that there is no tilt in the east or west directions.

Once again, all columns had clearly failed by the time the second and third photographs were taken (the failure of the northwest corner of the building (on the right) is visible to the naked eye in these photos):

Figure 6-10 which shows how the NIST misrepresents the movement of the building as the columns originally failed. The northwest corner, the last group of columns to fail, had clearly failed by the time the second and third images were taken.

10:28:20				Fig. 6-10 Fig. 6-11	WTC 1 began to collapse. The first exterior movement was at Floor 98. Rotation of the building section above the impact and fire zone to at least 8 degrees to the south occurred before the building section began to fall vertically.

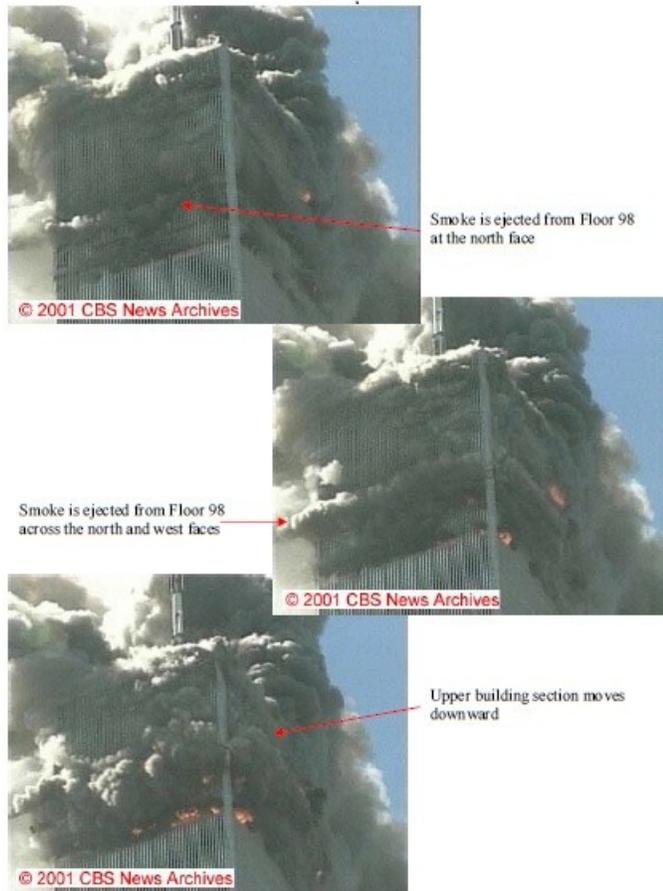
Figure 6-8. Smoke expulsion at Floor 98 from north and west faces as collapse initiates.

Once again, all columns had completely failed by the time the second photo was taken:

Figure 6-8 shows how the NIST misrepresents the movement of the building as the columns originally failed. The earliest visible ejections actually emerge from the 95 floor along the west face and are quite visible in video taken from this same viewing angle. The northwest corner, the last group of columns to fail, had already failed by the time the second and third images were taken (visible to the naked eye). The entire upper section was moving downward in the second and third images as measurements of the upper northwest corner clearly show. At the time the second and third images were taken, there were forceful smoke expulsions from the 88th floor, south face, 10 stories below the claimed collapse initiation area along the 98th floor and from the 77th floor, west face, over 20 floors below the 98th floor smoke expulsions shown by the NIST within these images.

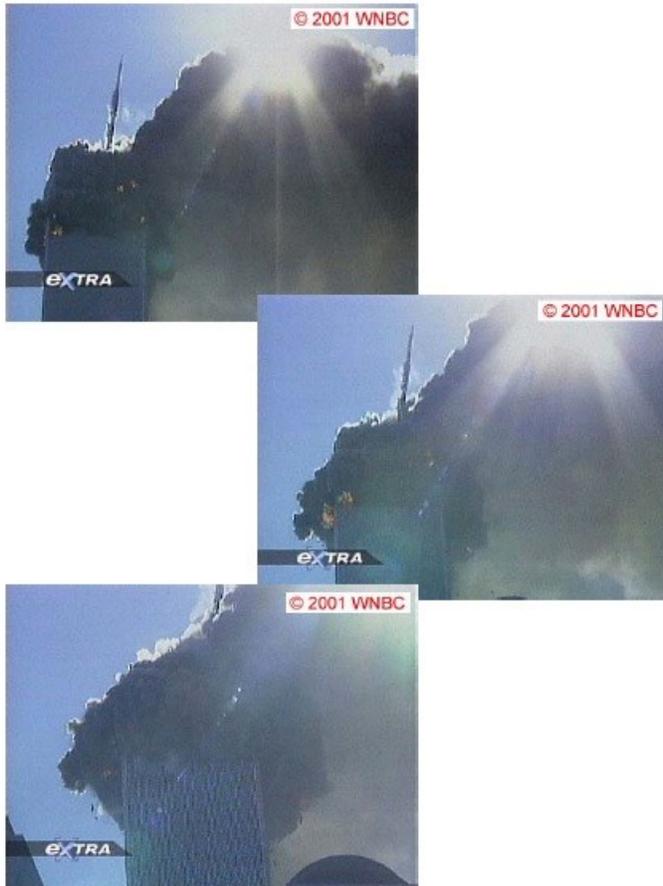
Figure 6-11. WTC 1 tilt to the south of approximately 8 degrees was measured before smoke and debris obscured view. Note view is from west and tilt is directly south.

In the next case all columns had completely failed before all 3 photographs were taken:

Figure 6-11 which shows how the NIST misrepresents the movement of the building as the columns originally failed. The northwest corner, the last group of columns to fail, had already failed by the time all 3 of these images were taken. The upper section was actually collectively sliding southward in all 3 of these images.
